NASA CR-72855
R-8406

PROTECTIVE COATING SYSTEM FOR A REGENERATIVELY
COOLED THRUST CHAMBER

FINAL REPORT

Contract NAS3-11187

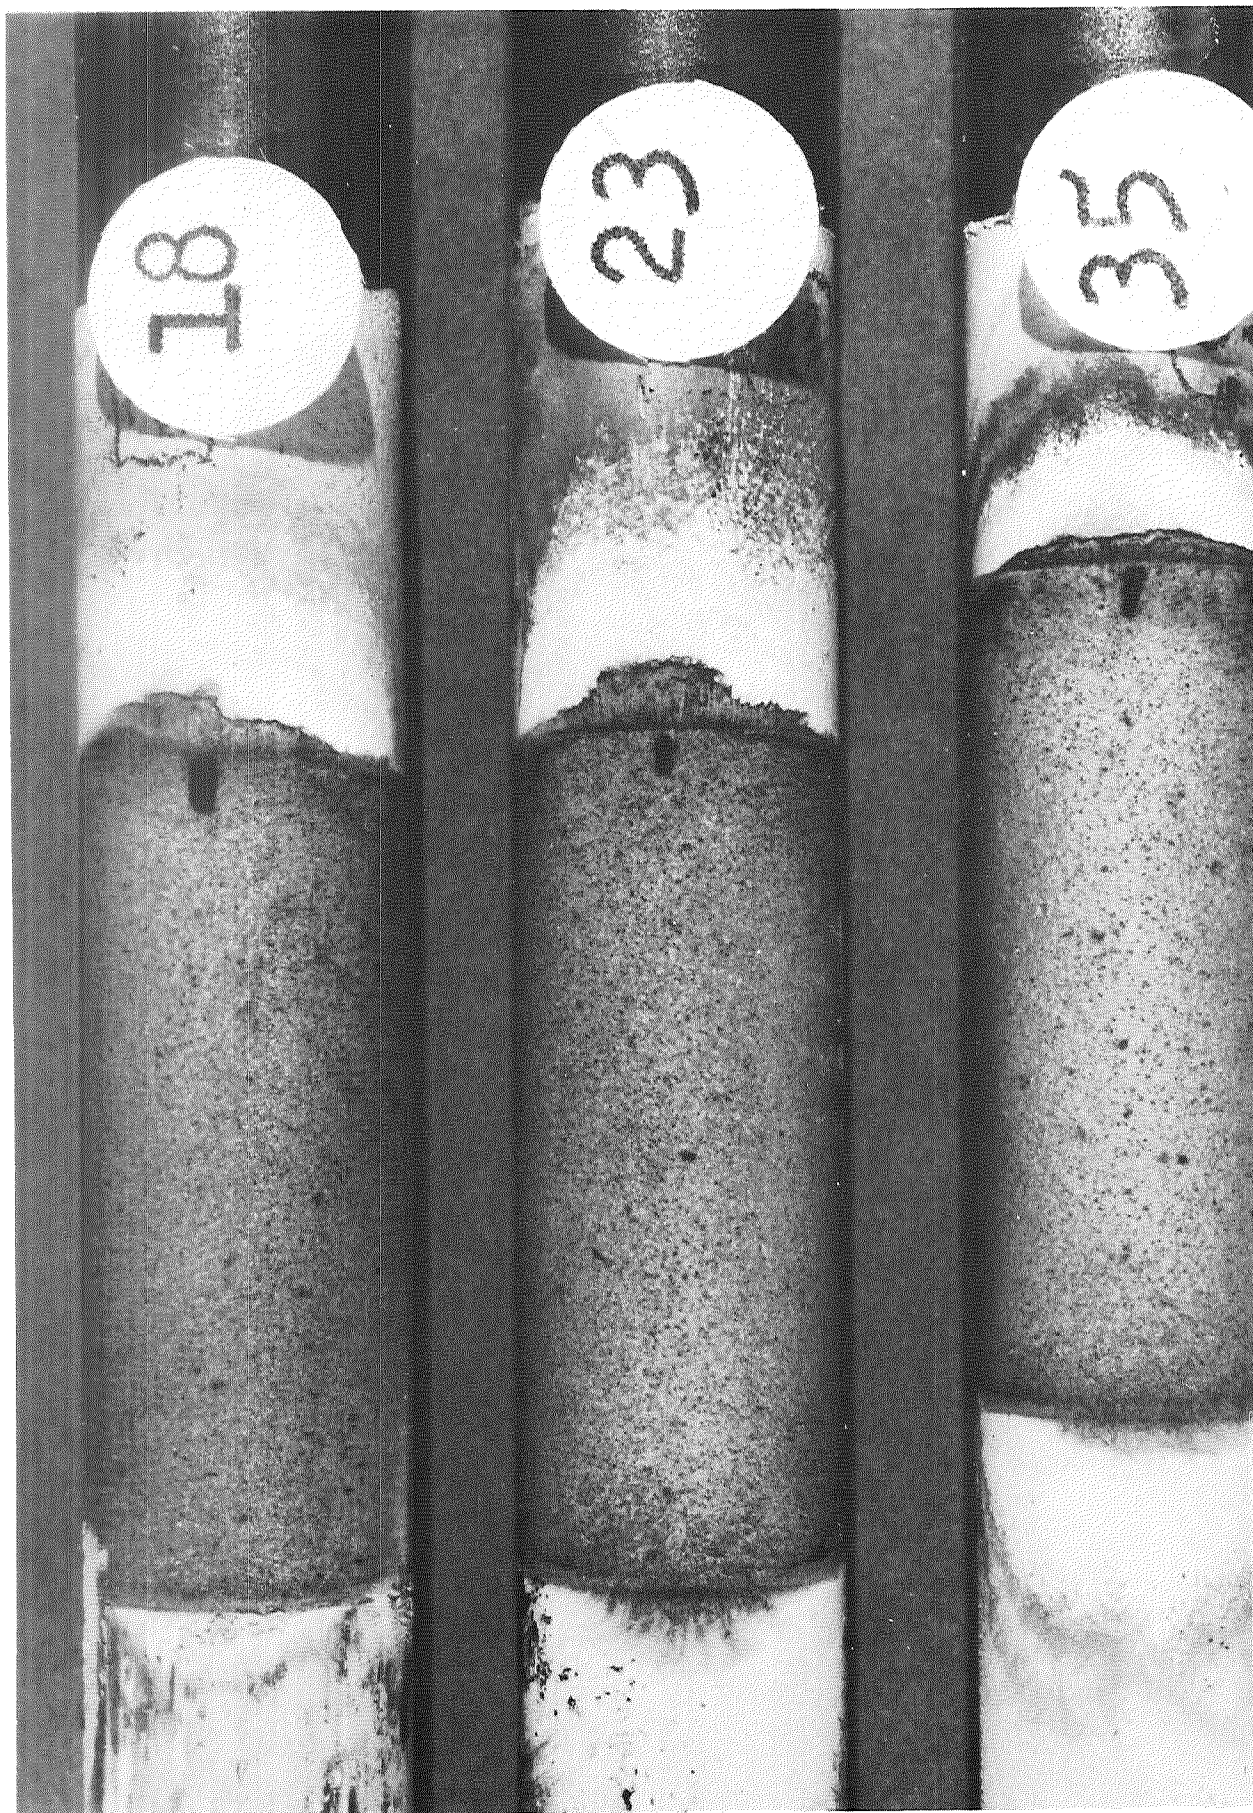
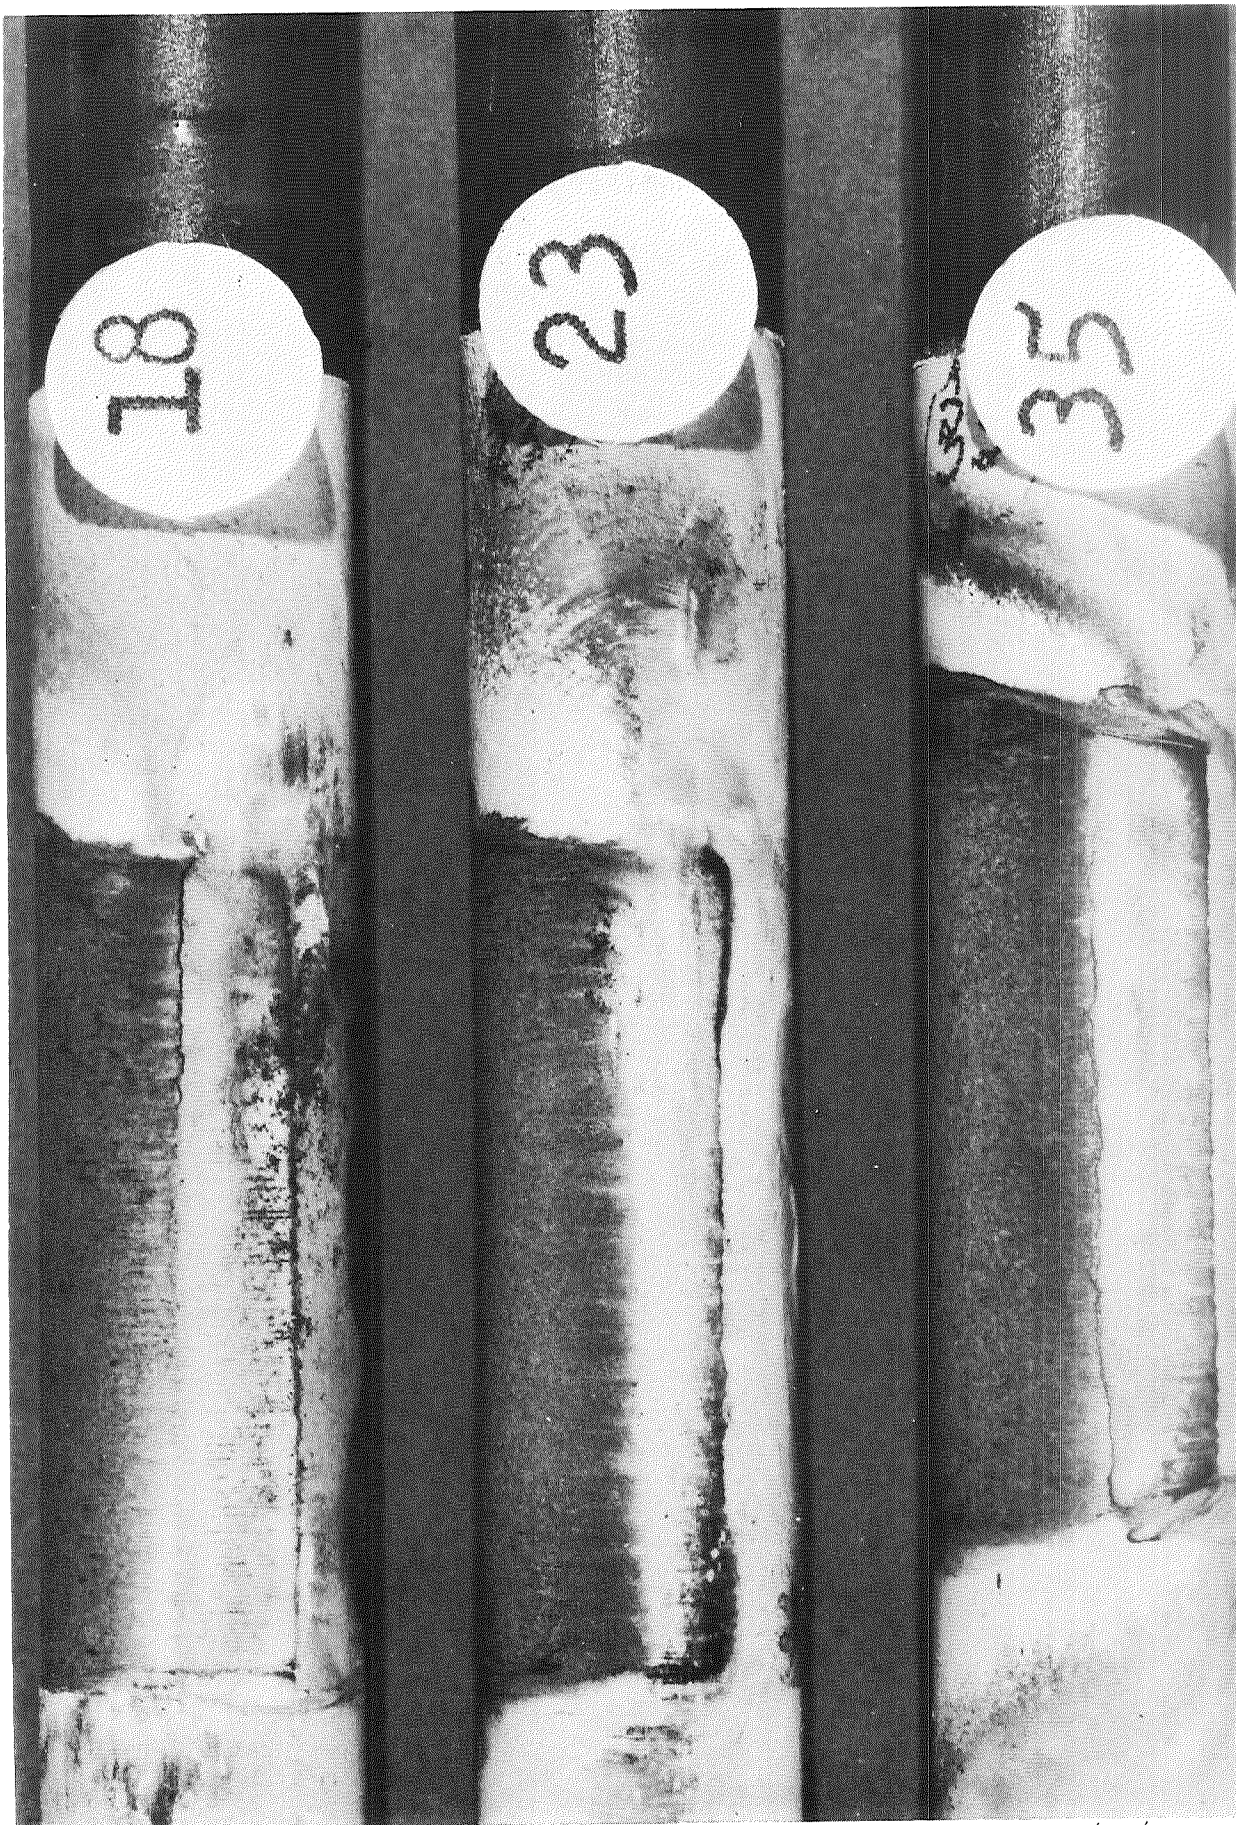
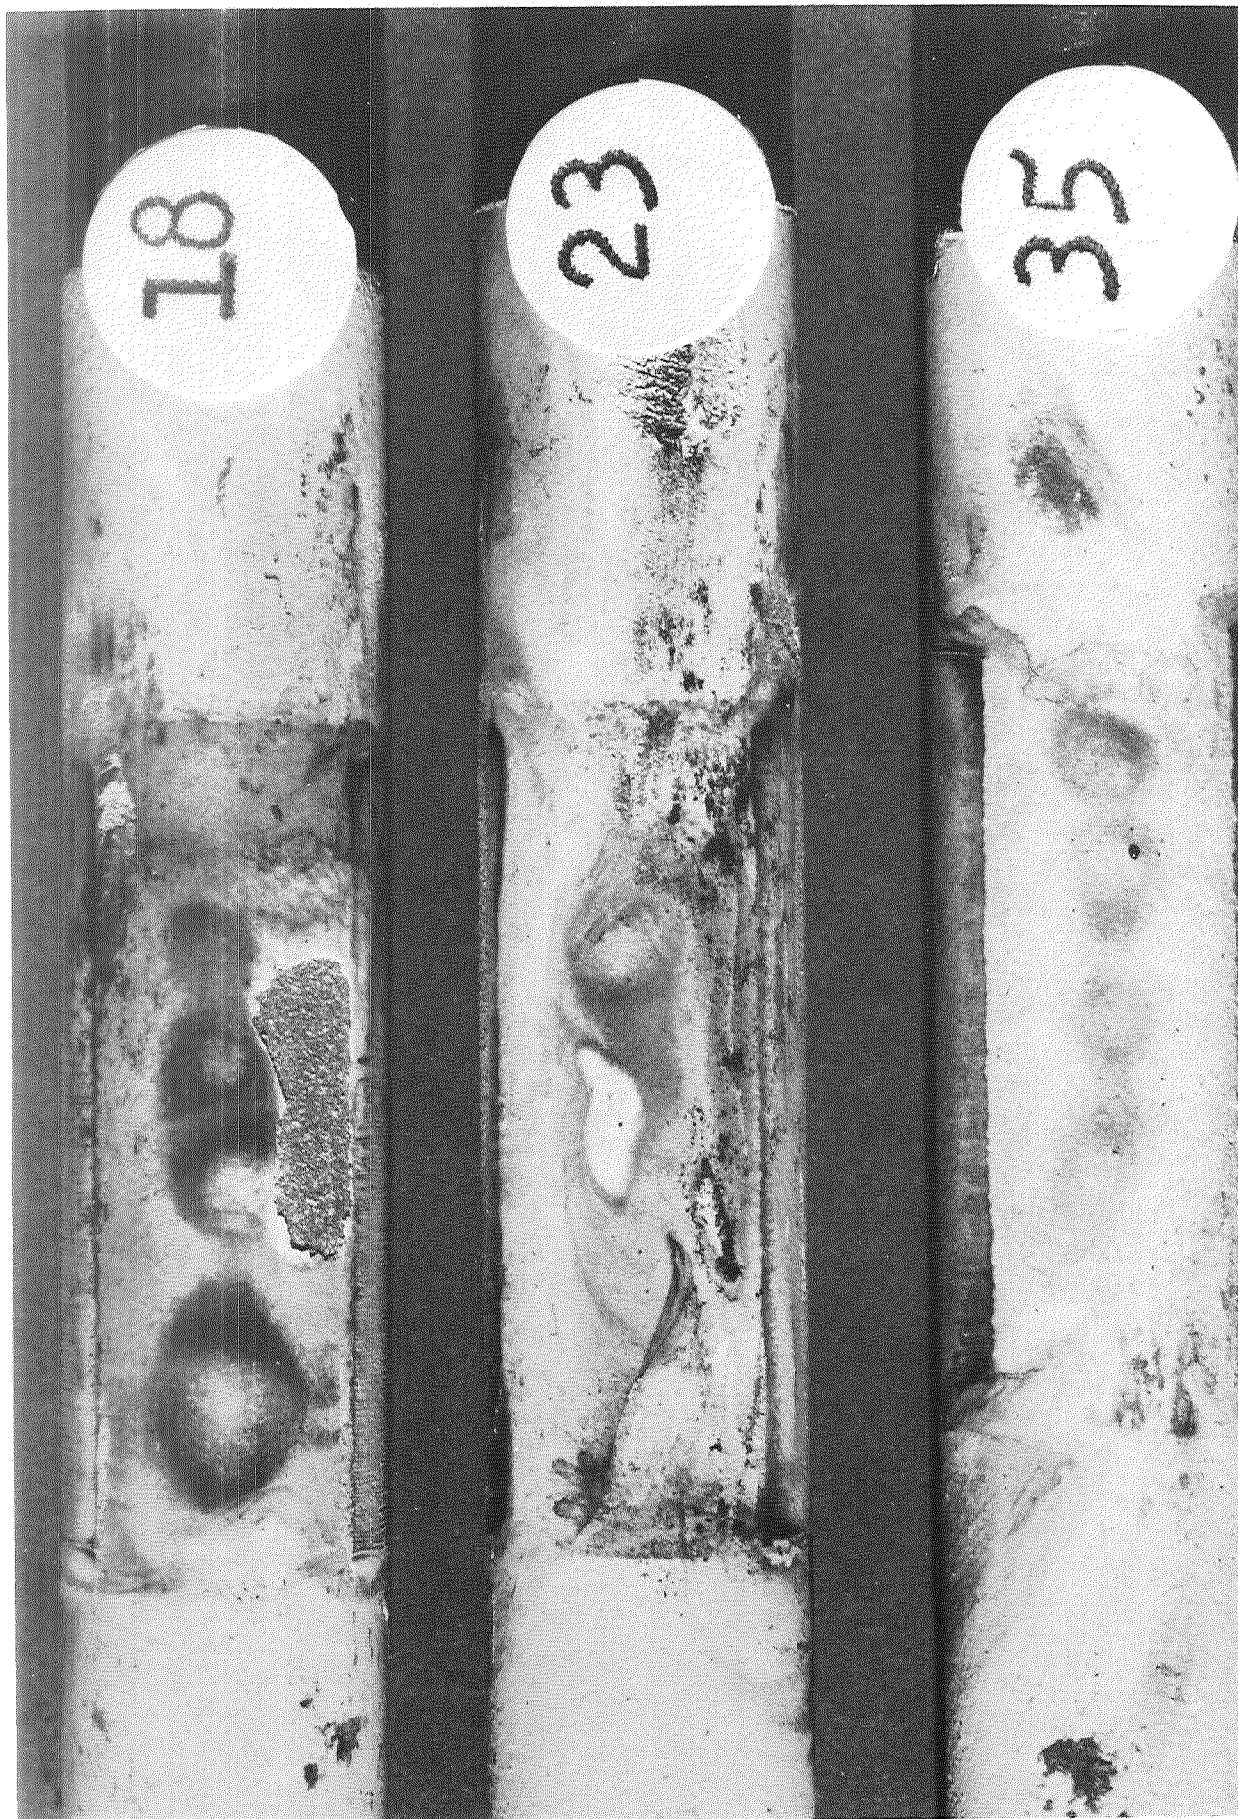
Figure 13. Coated-Tube Specimens After Rocket Engine Test at $P_c = 442$ psia.

(a) Front: The Surfaces Facing the Injector

(b) Side: $P_c = 442$ psia

(c) Rear: The Surfaces Away From the Injector. $P_c = 442$ psia.

Macroscopic Examination. Figures 12 through 15 show each test specimen in the posttest condition in front, side and rear views. Significantly, no spalling occurred, nor was erosion or any detrimental chemical reaction apparent in the test zone of the front face of any specimen (Figs. 12a, 13a, 14a, and 15a). The spalling seen in specimens 25, 28, and 32 (Fig. 14) occurred during removal from the throat fixture. Specimens 25 and 28 had to be sawed out while specimen 32 was physically forced through the entry hole. The difficulty in removal was caused by bowing of the tubes during testing. Bowing of the tube to this extent undoubtedly subjected the coating to untypically high stresses, particularly on the downstream side where the coating was placed in tension.

Inspection of the sides of the specimens (Figs. 12b, 13b, 14b, and 15b) also show that there was no spalling, erosion, or detrimental chemical reaction. Two significant features are readily apparent in these views. First, the point of gas flow separation is shown by the sharp edges of colored areas and by the abrupt end of the flow lines of fused coating. Color of these darkened areas was black and burnt sienna. The black smears originating at the ends of some test specimens are due to burned gaskets. Second, when spalling occurred on the downstream side of the specimen, it stopped where the gases separated from the coating surface. This is most apparent in specimen 26 (Fig. 12b and c) where downstream spalling was greatest.

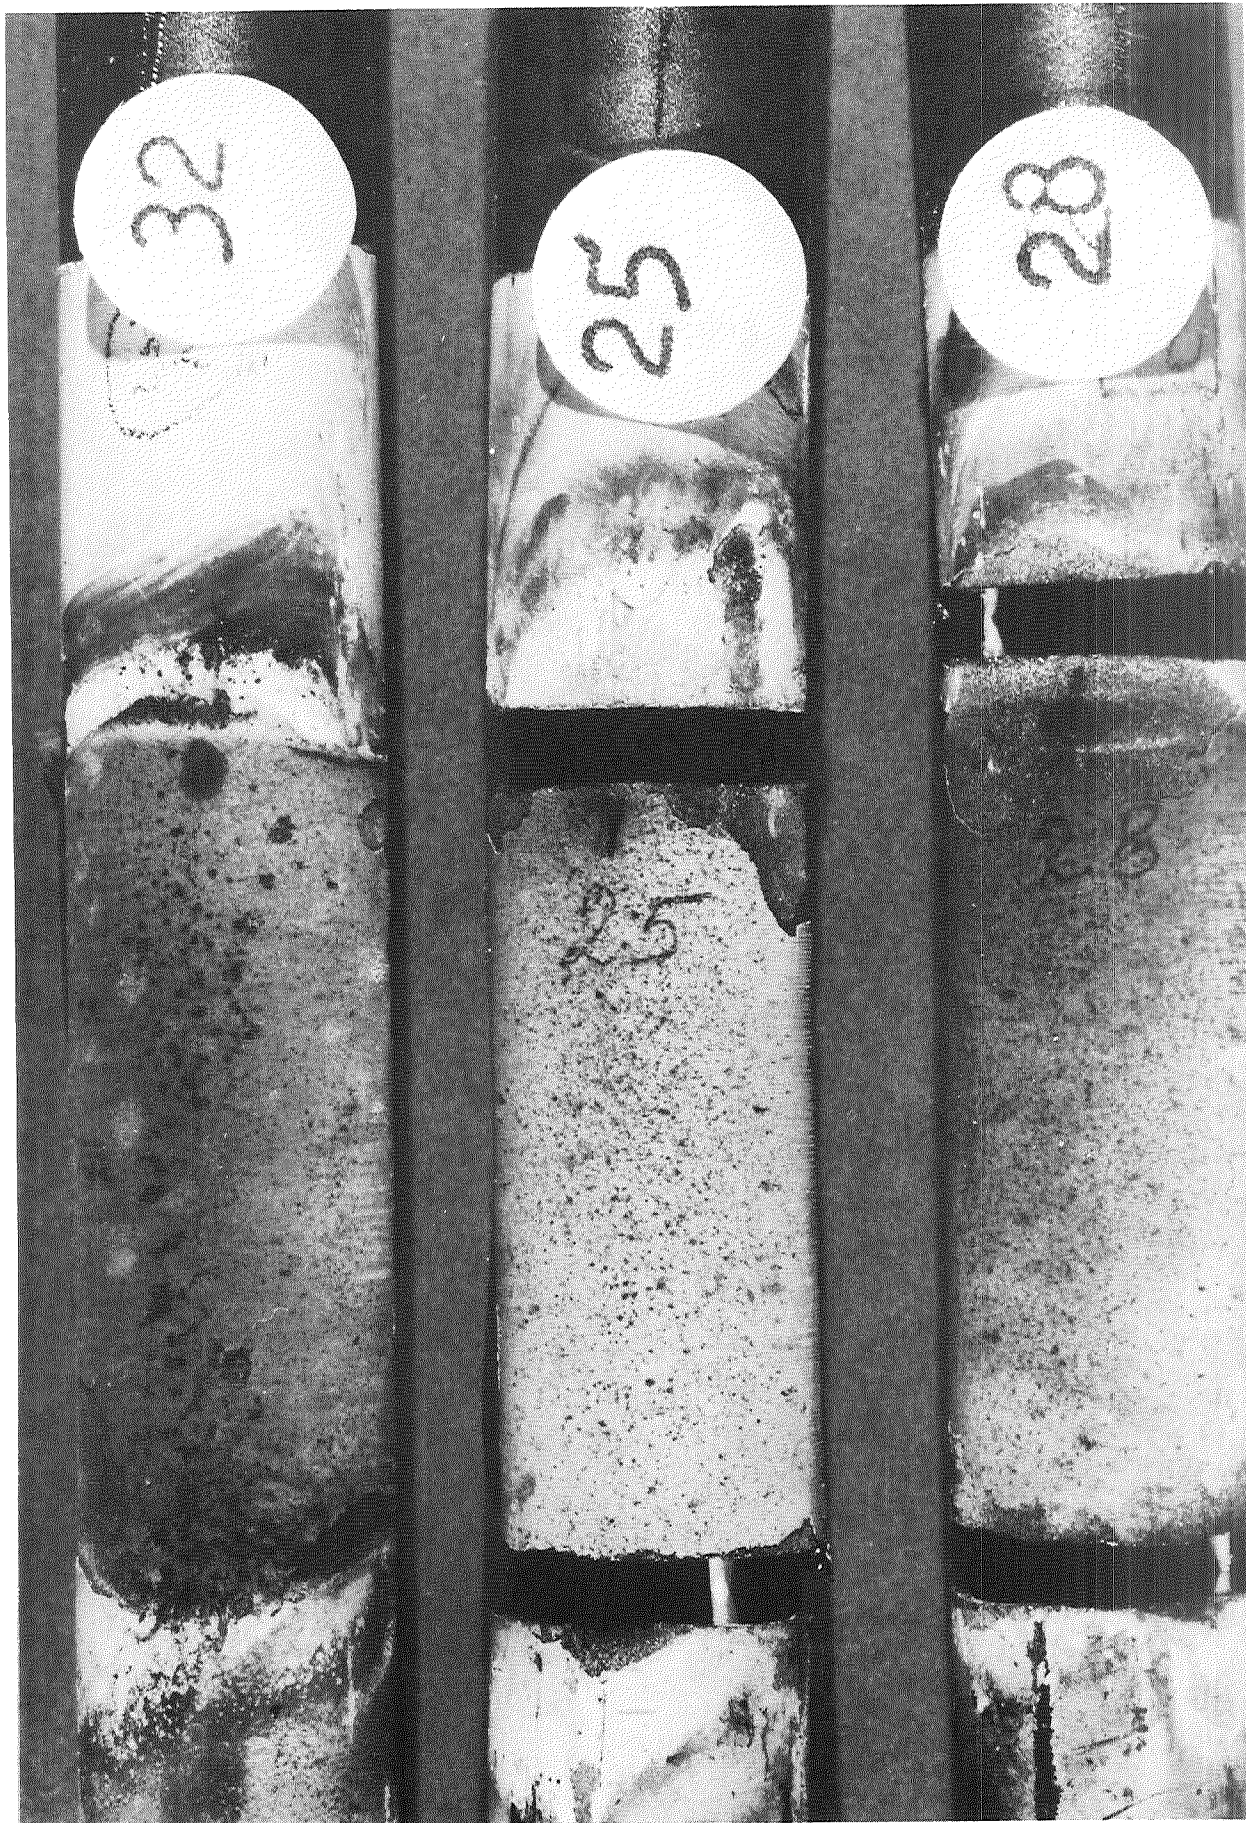
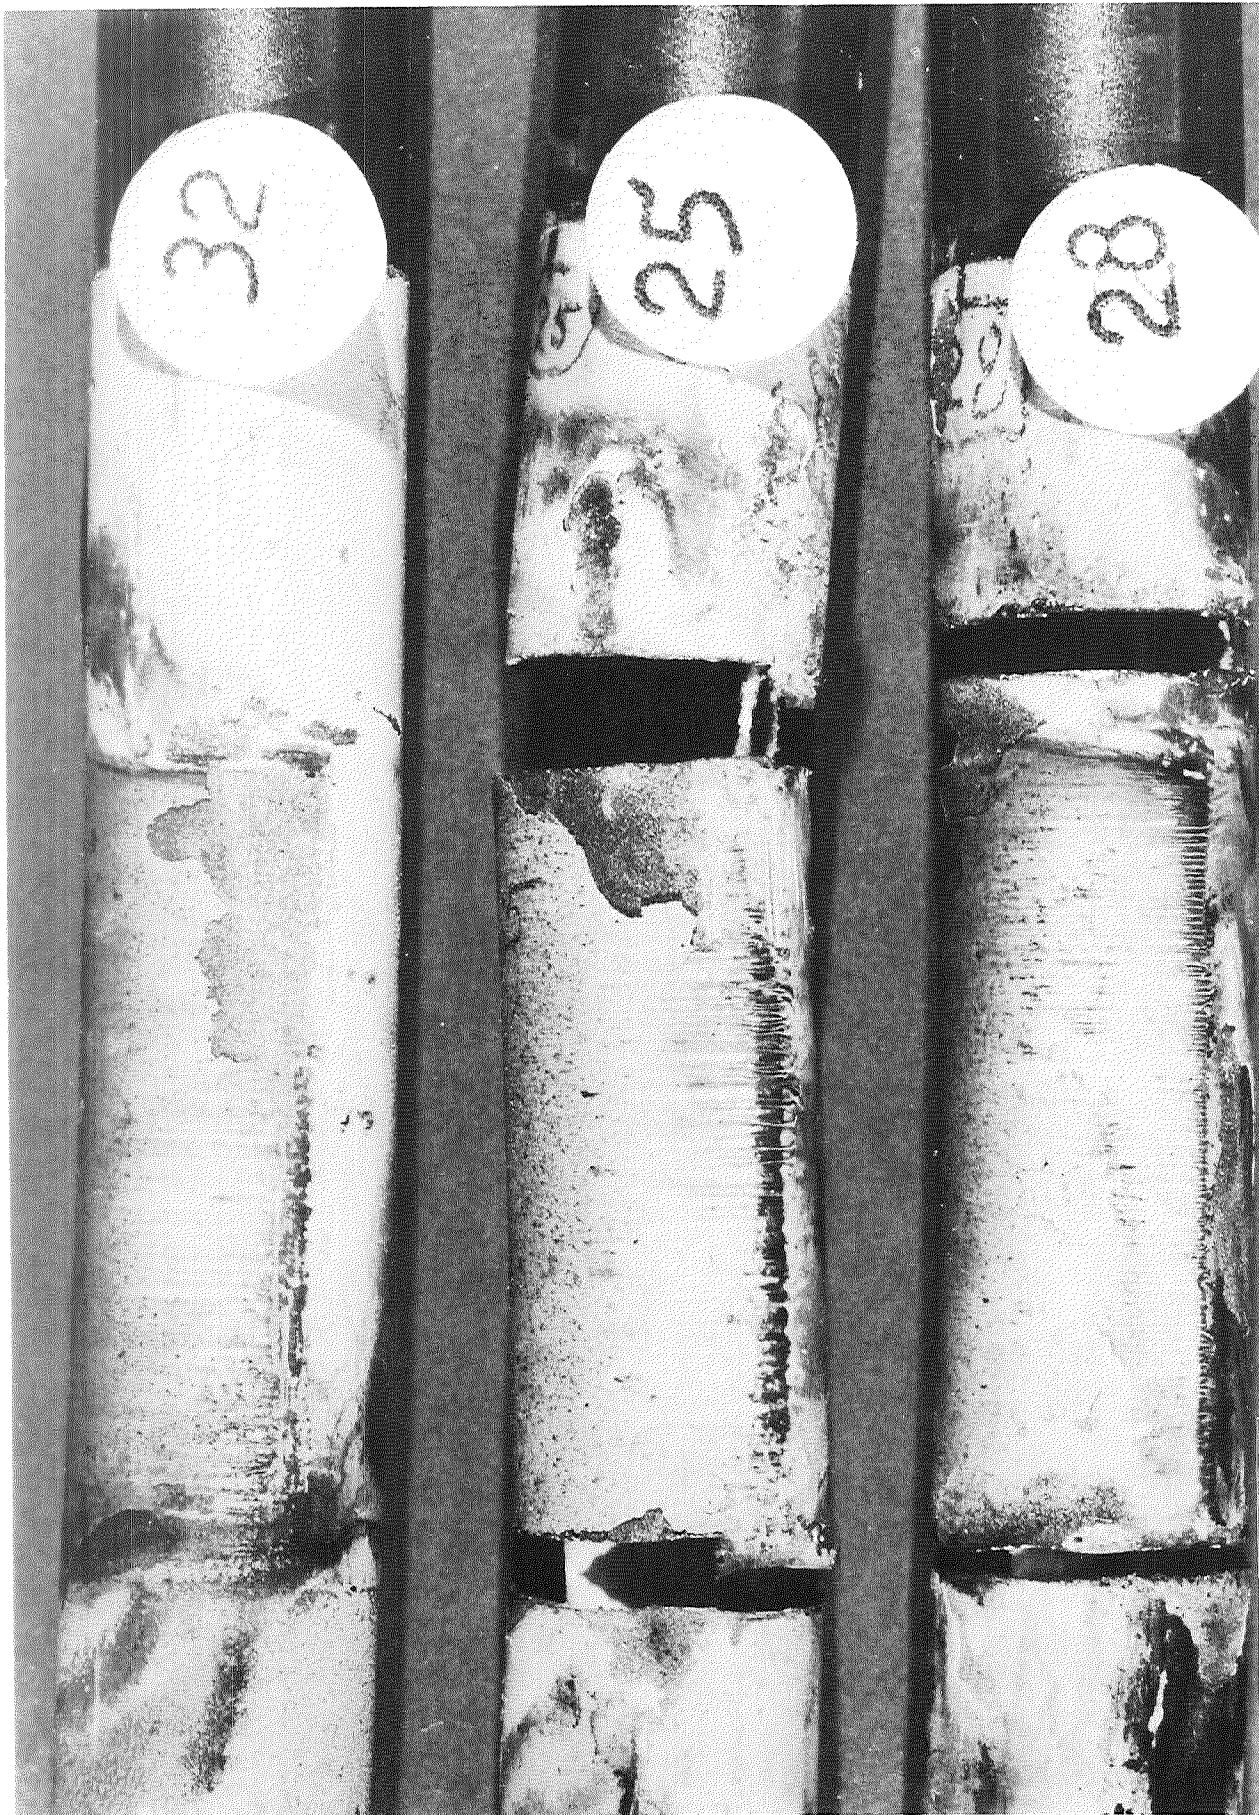
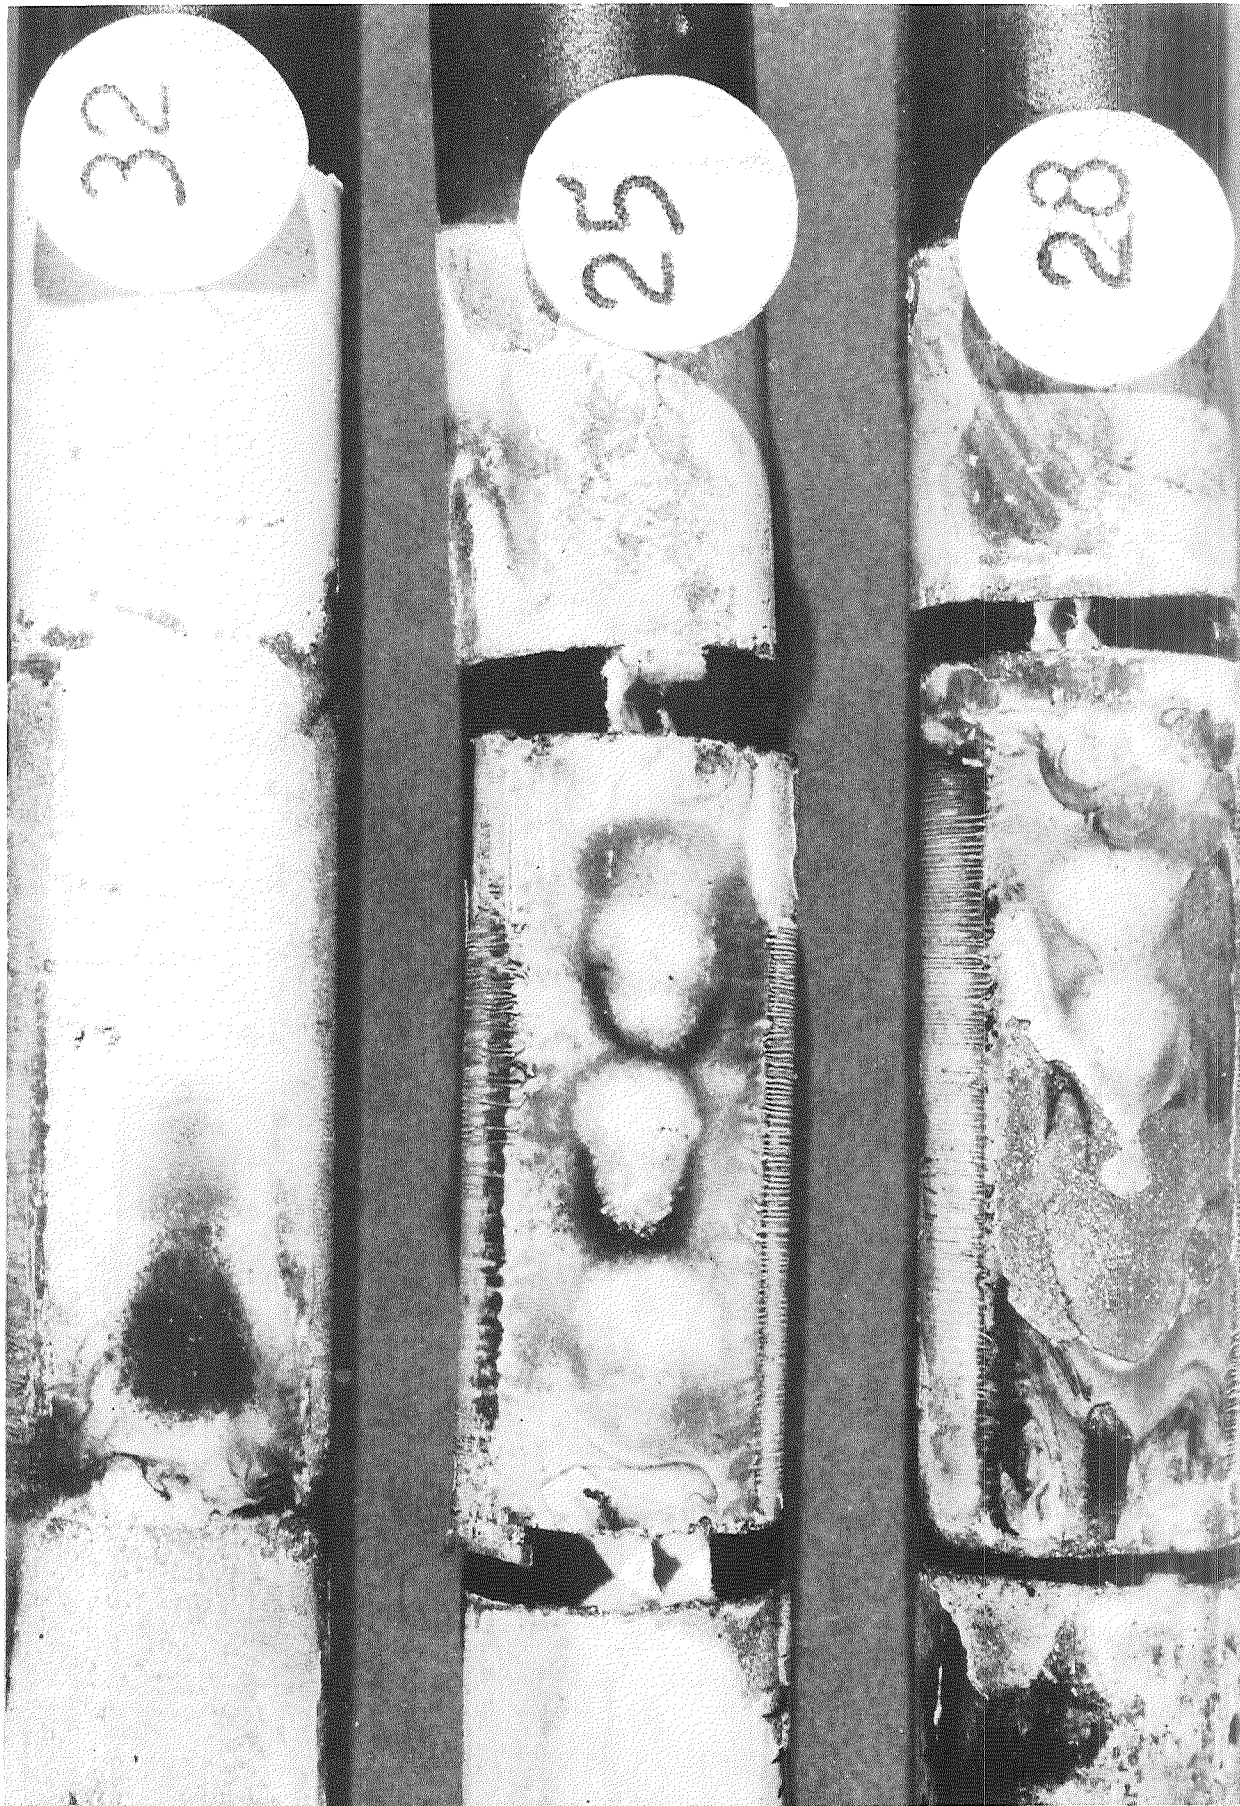
Figure 14. Coated-Tube Specimens After Rocket Engine Test at $P_c = 575$ psia.
(a) Front: The Surfaces Facing the Injector.

(b) Side: $P_c = 575$ psia

(c) Rear: The Surfaces Away From the Injector. $P_c = 575$ psia

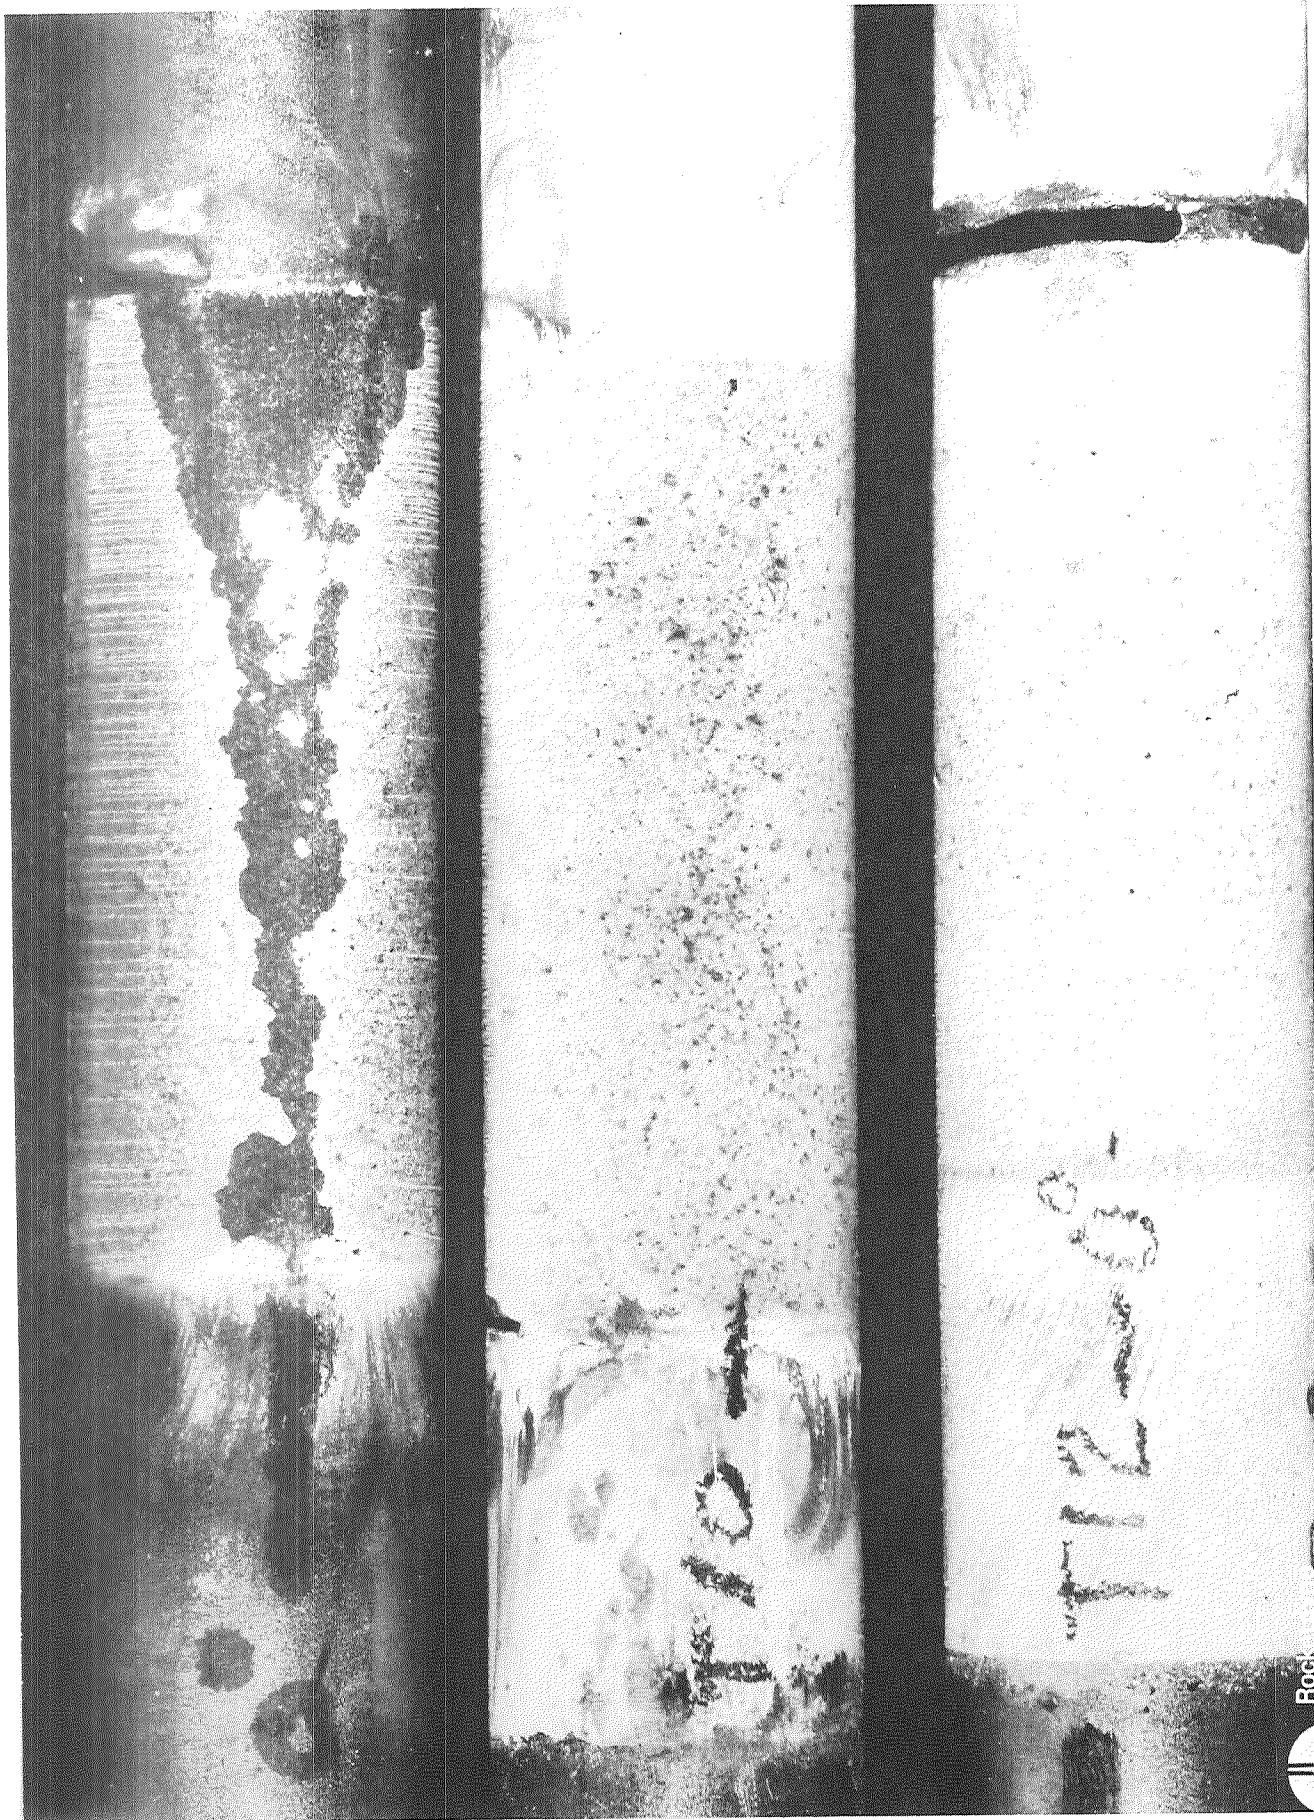
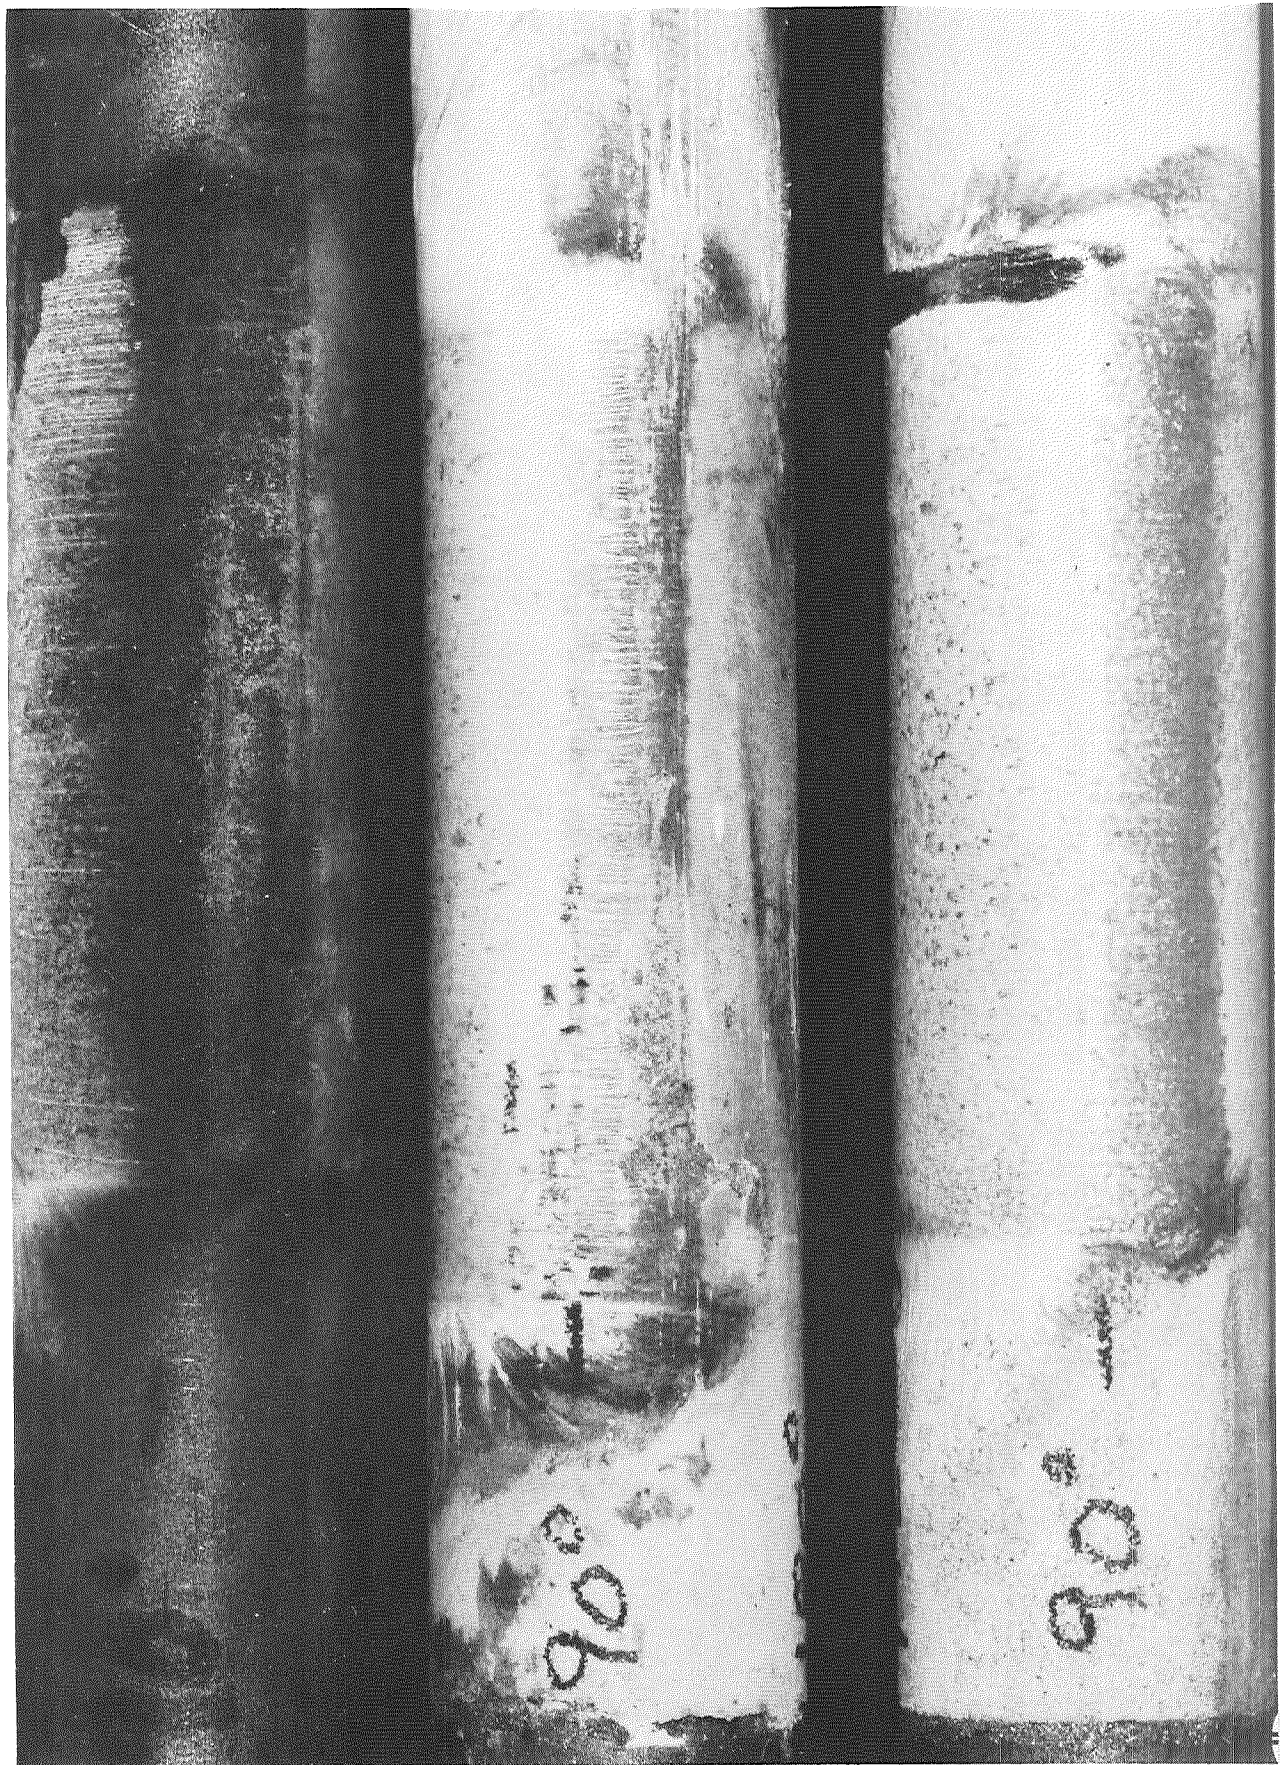
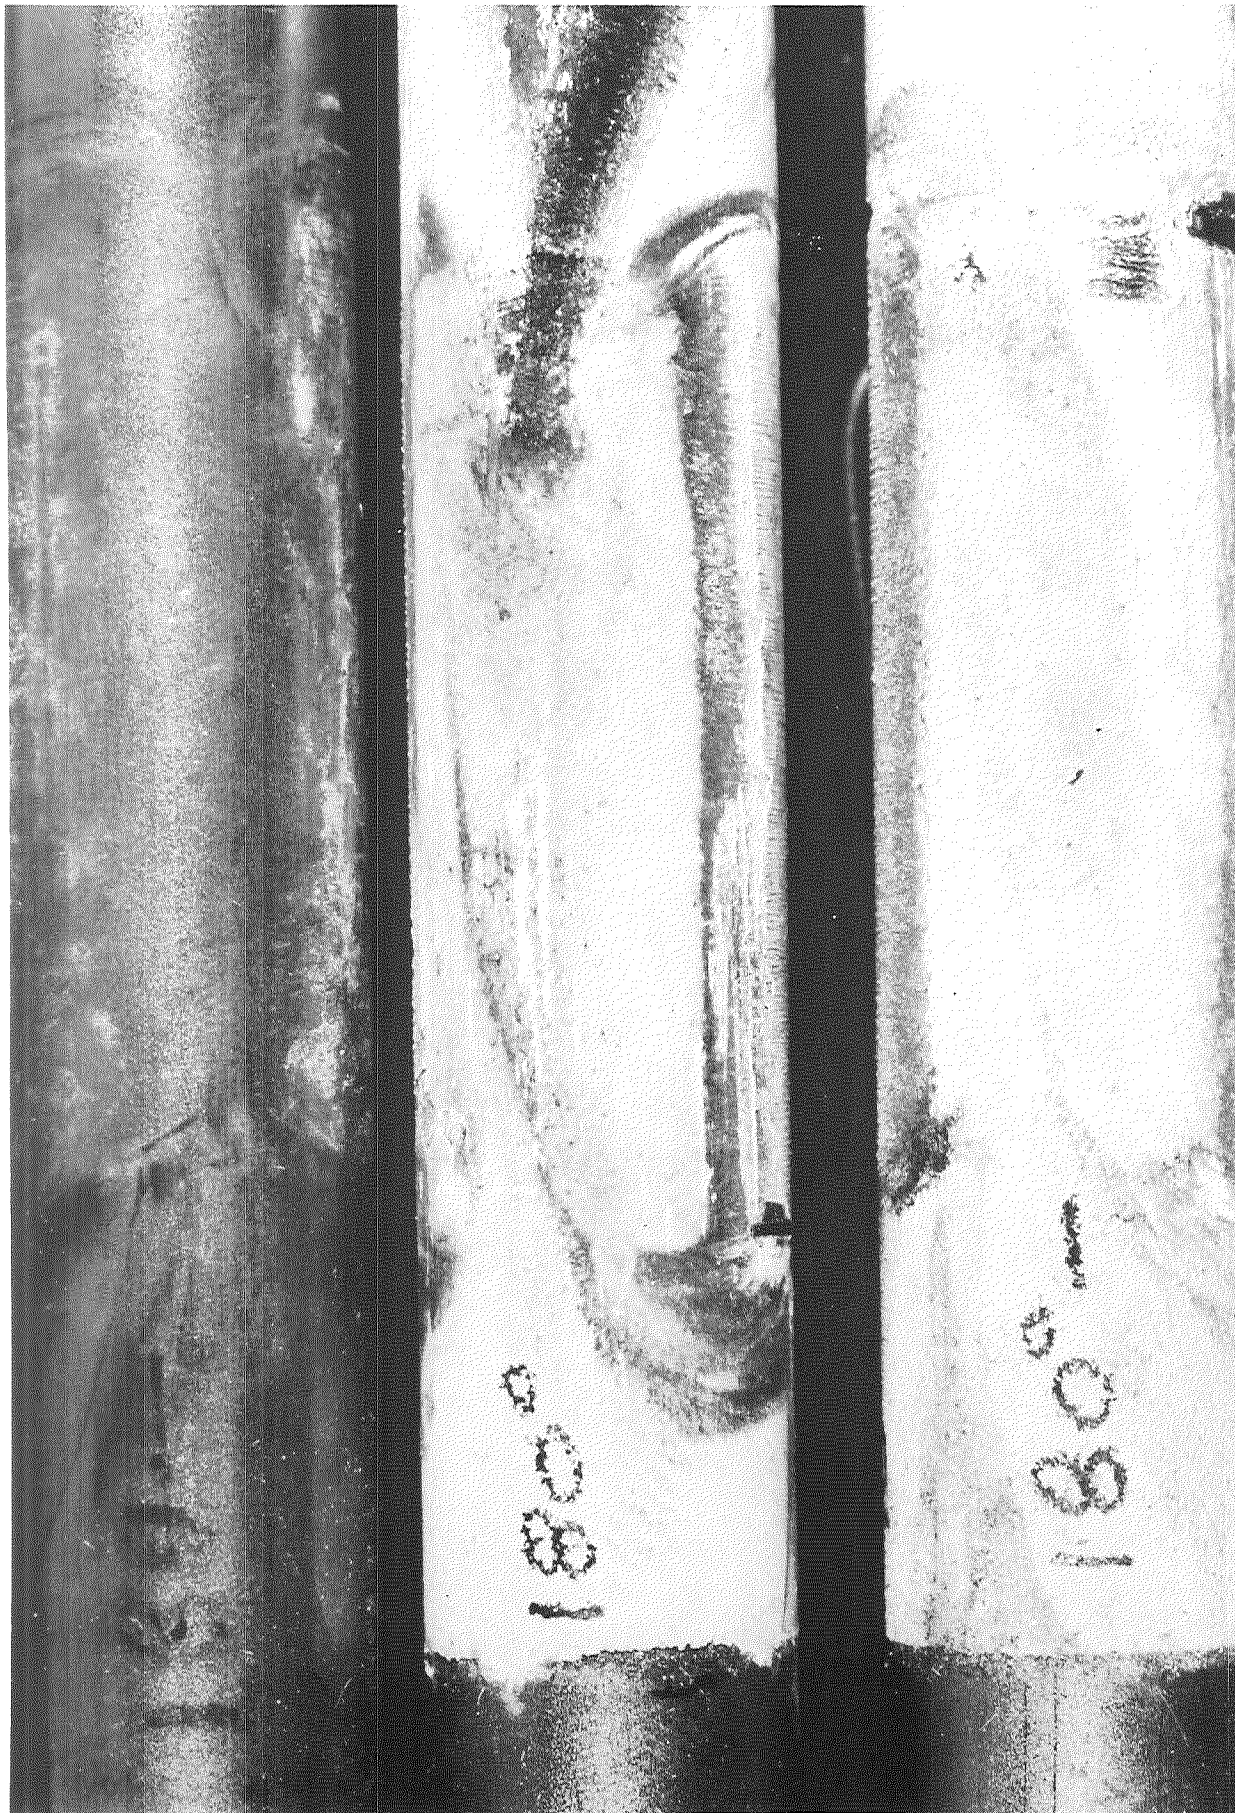
Figures 15a, b, c. Specimens After the Checkout Test Firings at $P_c = 302$ psia. From Top to Bottom: An Uncoated Hastelloy-X Tube, Specimens 10 and 12 Coated with Slurry B45. Magnification X4-1/2.

(a) Front: The Surfaces Facing the Injector

(b) Side: $P_c = 302$ psia

(c) Back: The Surface Facing Away From The Injector. $P_c = 302$ psia

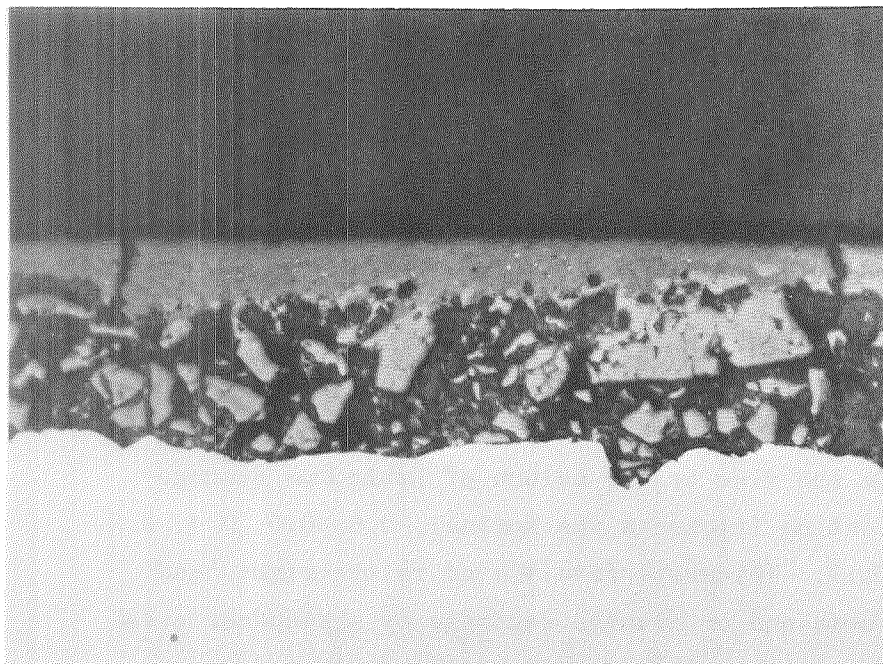
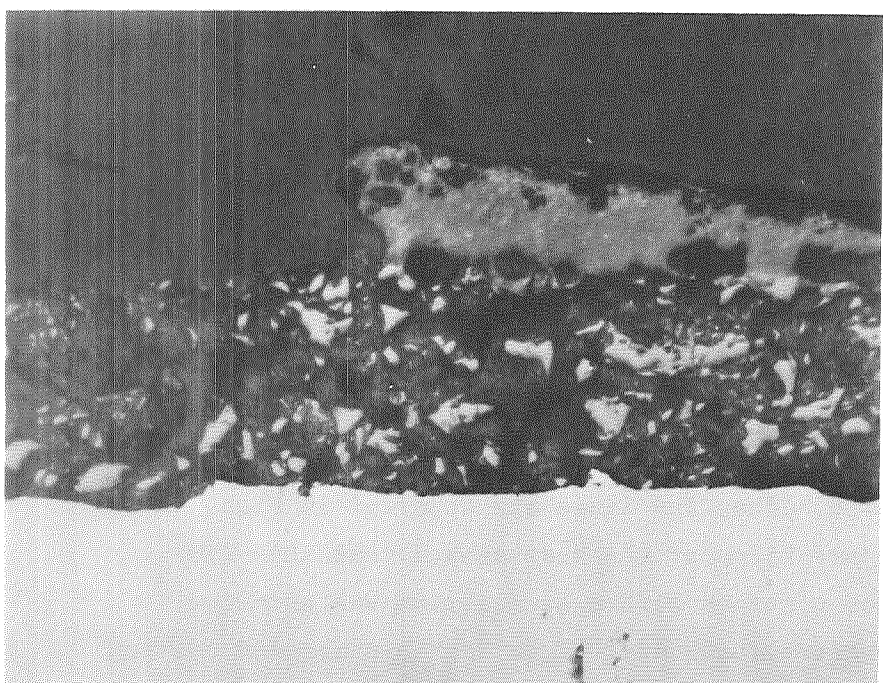
while the one at the bottom was located about 135 degrees from the stagnation point. The photomicrograph at the bottom shows the end of the flow line where separation of the combustion gases occurred. Fusion was observed, thus, from the stagnation point to 135 degrees to either side. Relating degree and depth of fusion to heat flux at any point around the circumference of the specimen, therefore, is somewhat difficult because, depending on coating thickness and the heat flux through the coating, fusion and/or sintering may not have wholly originated at that point. The fused surface, or a portion of it, could have been transported there from upstream. Note that the coatings under the flow lines in Fig. 16 show no effect of excess heating. For the majority of specimens, differentiating between zirconia grains that fused in place and those that were transported to that point in the molten state was not so easy as Fig. 16 suggests.

Fusion. The most apparent microstructural change in the coating was the fusion and/or sintering of the zirconia grains at the hot-side surface. Grains nearest the surface and in the highest heat flux areas actually melted and flowed. The flow lines are apparent in Figs. 12c, 13c, and 14c. Motion picture films of the test showed that this flow lasted only a fraction of a second before equilibrium was obtained. Figure 16 shows two photomicrographs of the coating in a mounted section that was polished to the middle of a flow line. The coated area in the top photomicrograph was located 100 degrees from the stagnation point,
